Removal of fractured endodontic instrument: a case report

Barbara Morsani Mordente¹
Camila Mansur Maffei^{two}
Emanuelly Rodrigues Santos^{two}
Gabriela Mikaelly Souza Cazassa^{two}
Sabrina Gomes dos Santos^{two}
Victor Lima Drummond de Castro³

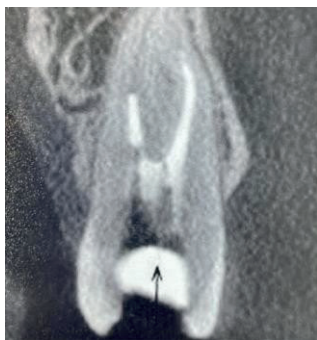
Figure 1:Computed tomography of element25 (oblique or parasagittal section).

Radiographically, the tooth presented a file fragment in the middle third of the vestibular canal. The palatal canal had an unsatisfactory filling. Endodontic retreatment of element 25 was proposed. To begin treatment, a Computed Tomography examination of the tooth region was requested, as can be seen in figure 2. The computed tomography was requested because, although periapical radiographs in endodontics are of great importance, , they are a two-dimensional examination, since the

note:The black arrows show the file fragment inside the buccal root canal, and unsatisfactory endodontic treatment in the palatal region.

In the first consultation, endodontic access to tooth 25 was planned. In this way, the opening began with a 1014 HL diamond spherical drill and removal of the temporary dressing that the tooth had. After locating the canals (Vestibular and Palatine), the tooth received absolute isolation and circular wear began with the ultrasonic tip EAD and E18D (HELSE) of the vestibular canal, then ultrasonic vibrations began with the tip E18 (HELSE) at 50% power. After 1 hour, the file fragment was removed as can be seen in figure 2.

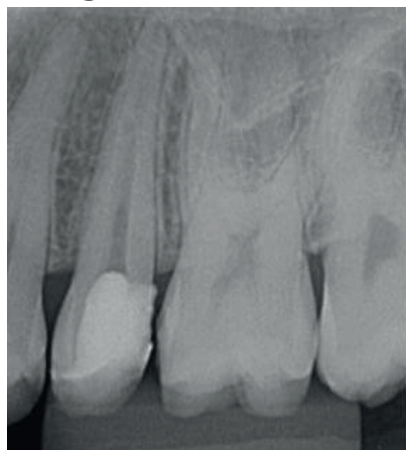
Figure 3:Element clear after cleaning and formatting

note:The black arrow indicates the canal after removal of the fractured file fragment, retreatment already carried out and intracanal medication.

After 40 ml of NaOCl, the canal was irrigated with a sufficient amount of EDTA for the compound to be activated 3x 30 seconds with ultrasound. Finally, 10 ml of hypochlorite were used again and activated with ultrasound. The canal was dried with absorbent paper cones and ultracal XS ready-made calcium hydroxide paste (Ultradent) was inserted along the entire length of the canal and cotton balls were inserted into the pulp chamber. The channel was sealed with ionoseal (VOCO), as can be seen in figure 3.
